## STABILITY ANALYSIS OF THE BUTTAHATCHEE RIVER BASIN, MISSISSIPPI AND ALABAMA

USDA-ARS National Sedimentation Laboratory Report Number 50

**Mississippi Department of Environmental Quality**

**November 2005**

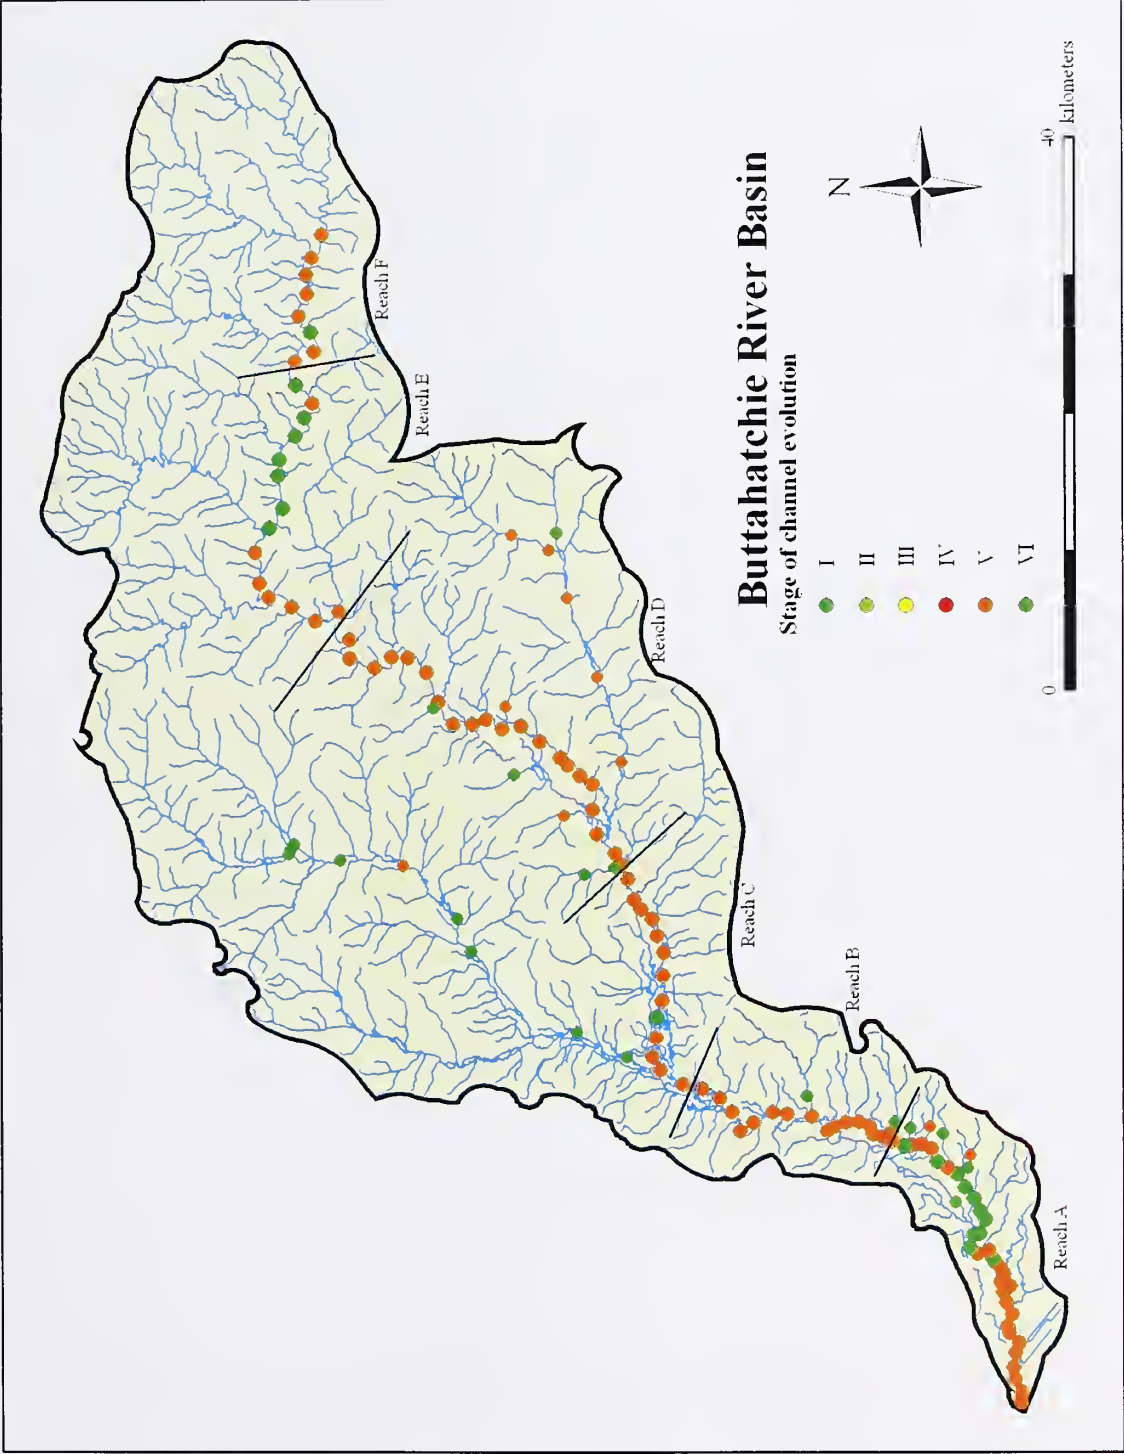
The RGA's carried out on the Buttahatchee River showed that all of the sites were either at Stage V (unstable) or Stage VI (stable) (Appendix D). Of the 108 sites visited along the river, 18 were found to be stable, and 98 were found to be unstable (Figure 40). The sites in reach A that were found to be stable, occur at the location highlighted in the air photo analysis, where some channelization of the channel seems to have occurred pre-1958 (A24-A27). In reaches D and E, the stable sites were located in an area where the channel is dominated by bedrock and boulder/cobble bed material. The other stable sites seen on Figure 40 are located on tributaries of the Buttahatchee River, including the Sipsey River (seen joining the main channel between rkm 59 and 60) and Bear Creek.

Figure 40 – Stage of channel evolution at each RGA site along the Buttahatchee River and its tributaries

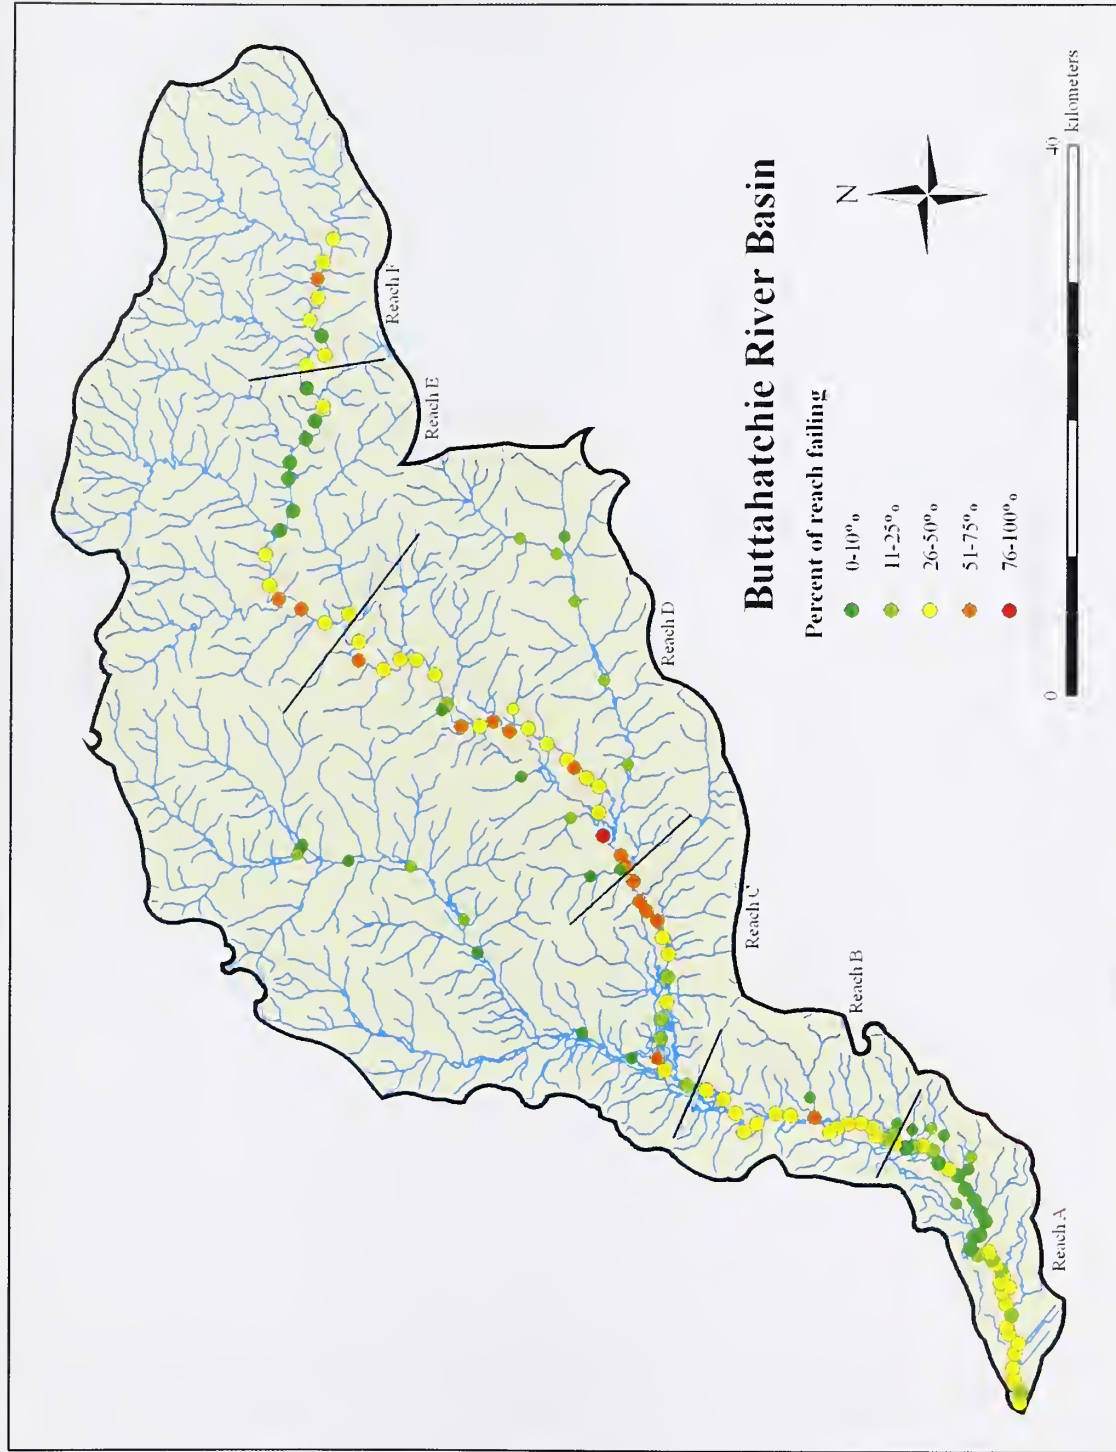
Figure 41 shows that the percent of reach failing at each site in A does not exceed 50% when both banks are averaged. In reach B, the majority of the sites have a percent of reach failing estimate of 25-50%, and one site has a value of 50-75%. Apart from one site in the lower part of reach C which has a value of 50-75% reach failing, the lower part of reach C seems to have lower percent reach failing values than reach B. However, the upper part of reach C and lower part of reach D have many sites where percent reach failing is 50-75%. One site in D has percent of reach failing in the highest category of 76-100%. High percent instability remains up into the middle of reach E, where the sites in the areas of rock outcrop are more stable. Upstream into reach F again the percent of reach failing mainly falls into the 26-50% category.

Figure 41 – Percent of reach failing at each RGA site along the Buttahatchee River and the lower ends of its tributaries

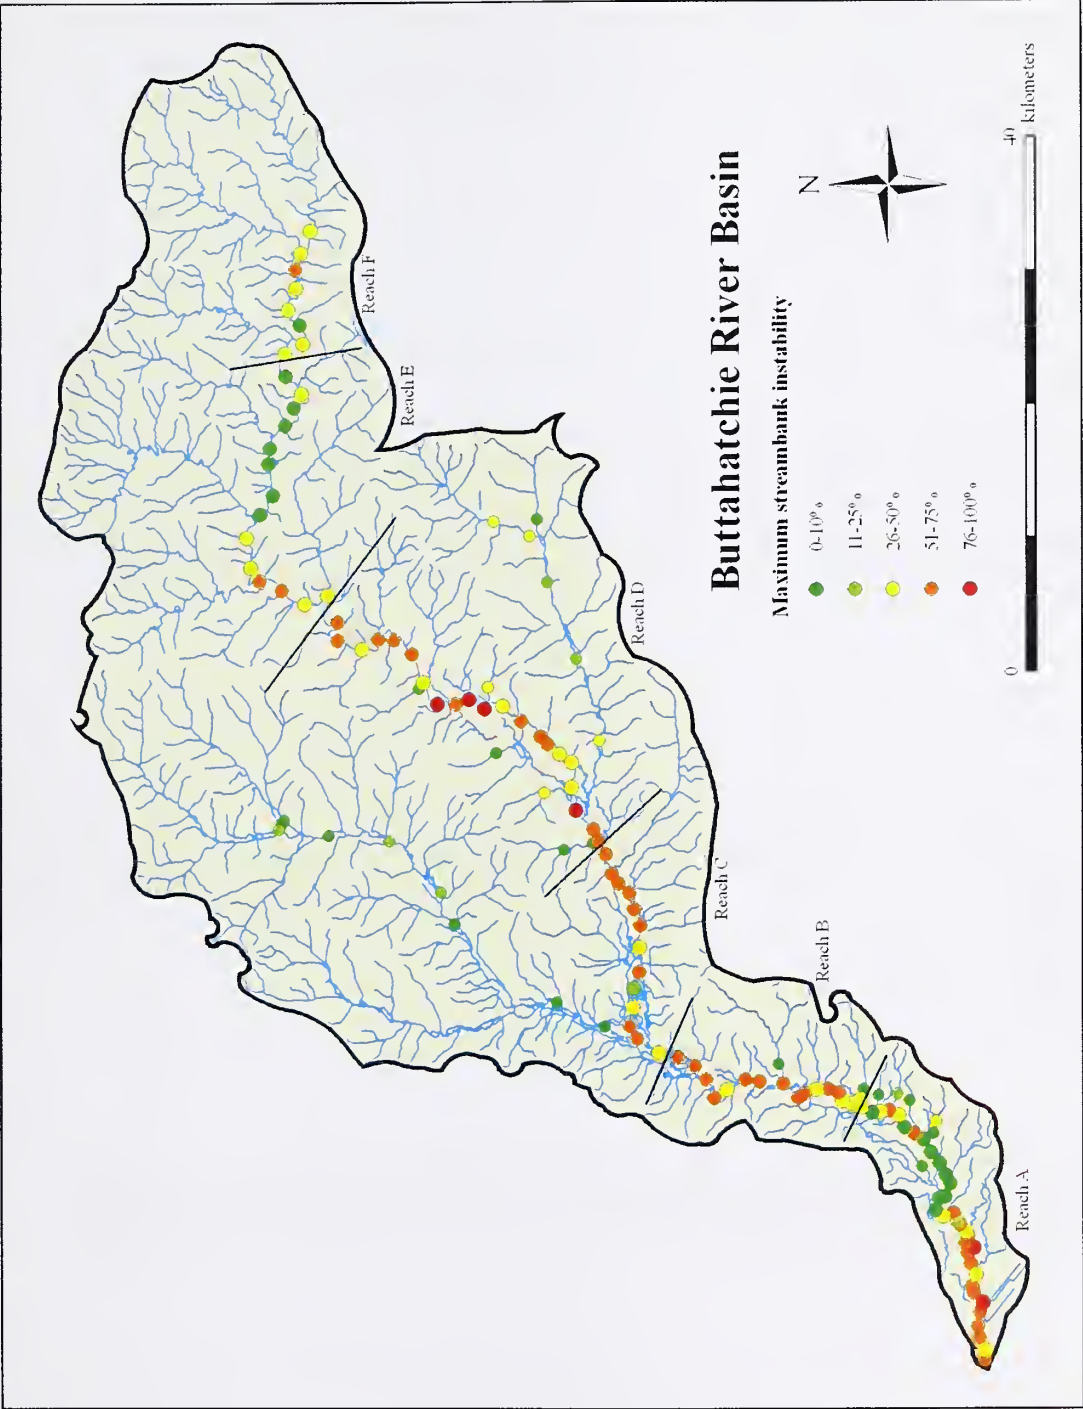
Figure 42 shows the maximum percent streambank instability at each site, and may be more useful in highlighting areas where streambank stabilization measures would be most effective. The lower 20 km of reach A, and large sections of reaches B, C and D have at least one bank (in general outside banks) where percent failing is 50-75%. The most unstable banks (76-100% failing) are located in the lower half of reach A, and in reach D. Tributaries appear to have relatively low percent reach failing at all sites visited. The lower part of reach A is particularly susceptible to severe bank erosion because of the disturbances that have affected this reach, including meander cutoffs between 1958 and 1981, impoundment of the TTW causing greater saturation of the banks and the capture of the gravel mines below the Hwy 45 bridge. In reach D, notes taken during the helicopter flight suggest that the outer bends of the meanders are the most unstable parts of this reach, with large sand bars being depositing on the inner bends and in the straight riffle areas, which seem to be experiencing less (but still some) bank erosion. The meander belt in reach D, therefore, seems to be actively widening, possibly as a response to the positive feedback loop established in this reach from an excess of sediment delivered to the channel from the uplands, forest clear cuts that occurred predominantly in the 1981 to 1992 time period, and agricultural land-use. This excess sediment is deposited on sand bars that then deflect flow at the meander bends in such a way as to increase bank erosion, and thus sediment delivery to the channel.

Figure 42 – Maximum streambank instability at each RGA site along the Buttahatchee River and the lower ends of its tributaries

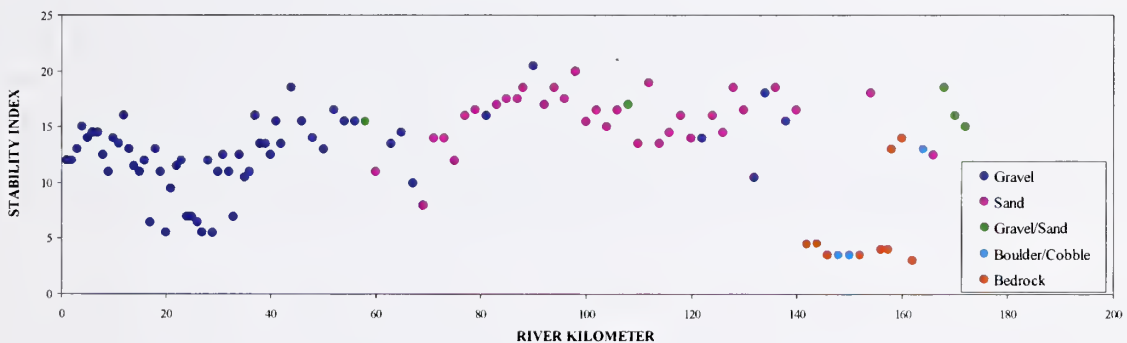
Figure 43 shows the channel stability index obtained from RGA data, plotted against river kilometer, and separated by dominant bed material. It can be seen that almost all sites were found to be unstable (stability index  $> 10$ ), with a few sites in reach A being relatively stable (around rkm's 24-30) having undergone channel modifications in the past (see Section 5.1), and some sites in reach E being relatively stable due to the bedrock/boulder/cobble bed material. General instability exists at the remaining sites, with local peaks in instability occurring below rkm 10 in reach A (where disturbances have been concentrated), at rkm 44 in reach B, and at rkm's 90 and 98 in reach D. In reach C, between rkm's 60 and 75, the stability indices for all sites visited were below 15. Therefore, whilst these sites still exhibited moderate instability, this section of the river was more stable than many of the sites upstream and downstream. This stretch of the Buttahatchee River may not yet have experienced the upstream progression of instability resulting from disturbances in the A reach. As bank materials appeared to be fairly consistent across the samples taken at BST sites for reaches A to F (all containing high percentages of sand, with localized concentrations of gravel), the higher stability of these sites in reach C compared to upstream in reach D, may be related to land use changes within the Buttahatchee River watershed. Land use changes are discussed further in section 5.2.6. Rkm D98 is the area in which the large debris jam was recorded. Instability around this location was seen to be high because the log jam causes sediment to be trapped behind the debris, allowing the river to scour downstream of the debris jam.

**Figure 43 – Channel stability index for each RGA site, plotted against river kilometer upstream of the TTW, and separated out by dominant bed material type. Dashed lines indicated those sites that are stable (index  $< 10$ ), and unstable (index  $> 10$ ).**

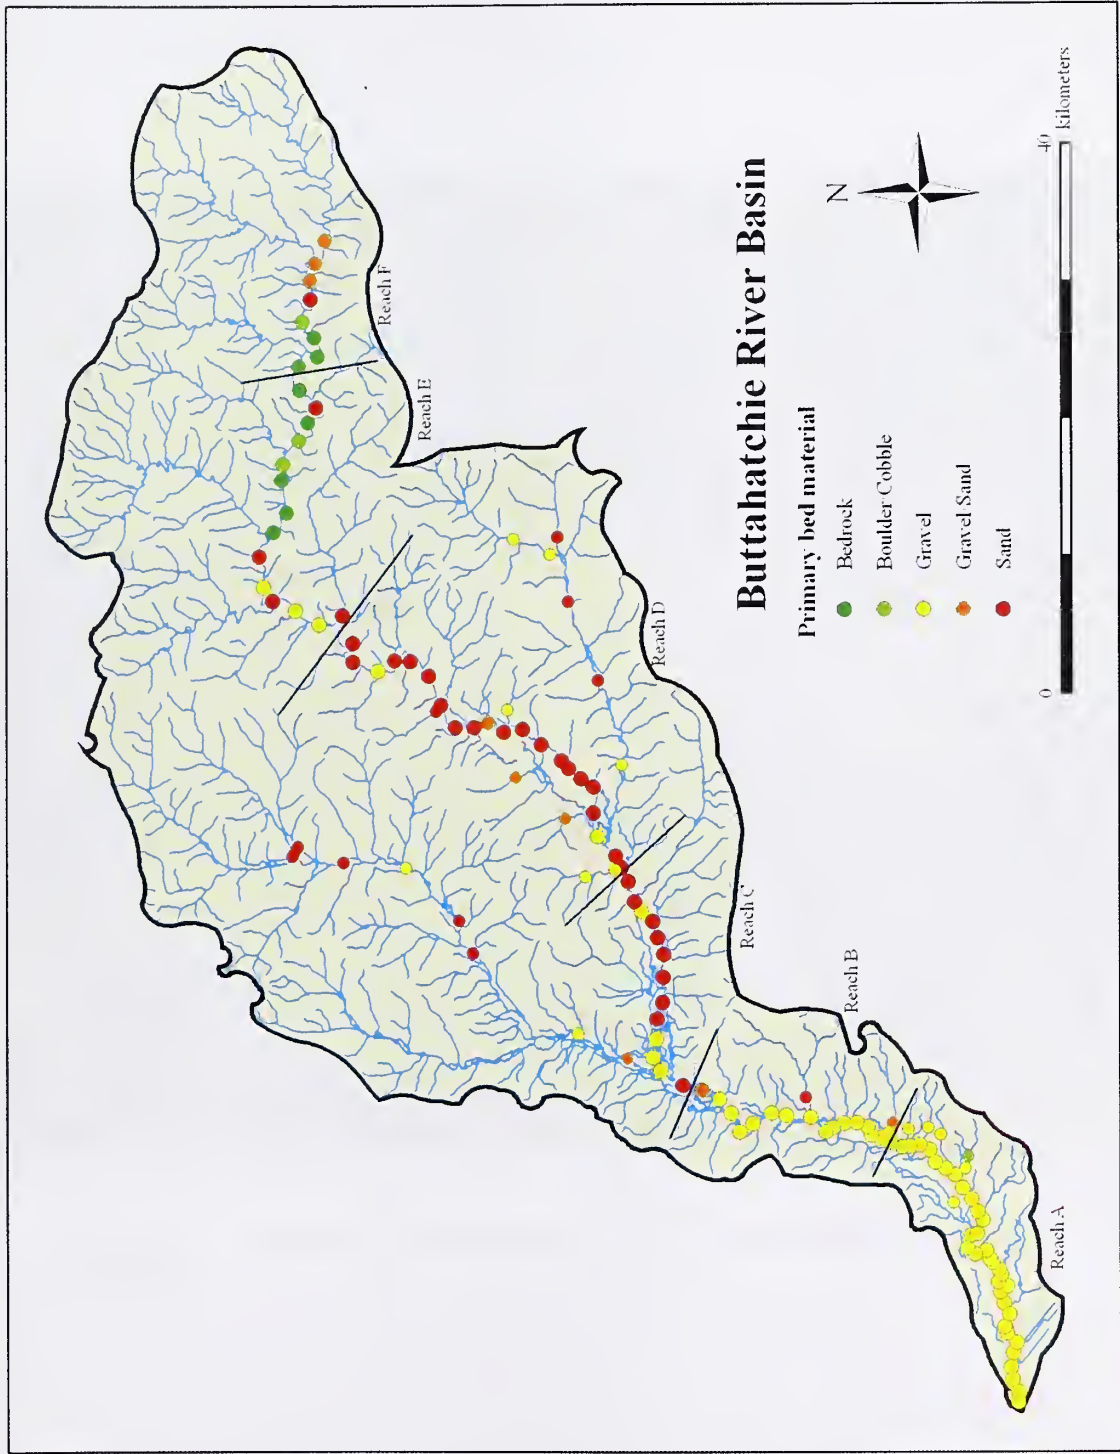
RGA's showed that the beds of Reaches A and B are dominated by gravels (Figure 44, Appendices C and D), although bars in these reaches were composed of a mixture of sand and gravels. The partially armored gravel beds seen in these reaches are features of scour, and indicate that the channel in these reaches has sufficient energy to transport finer material through most of the thalweg, with deposition of finer sediment occurring mainly on bars. At some sites (particularly above Hwy 45 bridge and up into Reach B), gravel clasts were stained black with a manganese oxide which has precipitated from ground and stream waters (Patrick *et al.*, 1996), indicating a relatively stable bed. In reaches A and B, even where gravel dominates, aggradation is a common feature, with large deposits accumulating as bars, thus increasing the energy in the deeper areas where flow is deflected, maintaining the gravel bed. One cause of aggradation in the lower reaches has been the impoundment of the Columbus Pool, and the resulting raising of the base level of the Buttahatchee River. In addition, the large amount of sediment being delivered to the lower reaches from streambank instability and land-use issues in the upper part of the watershed also contribute to the inability of the channel to transport all of the sediment.

In addition, bank instability is also occurring throughout reaches C and D of the Buttahatchee River, so some of the sand found on the bed there is coming directly from the banks themselves. (the bank materials in all the reaches contain high percentages of sand with gravel deposits also present at some locations) At some locations in reaches C and D, gravel was found in larger quantities on the bed which may suggest that there is gravel underneath all of the sand bed material, but sampling in this study was unable to confirm this. The large amount of sediment present in the upper reaches of the Buttahatchee River, particularly in reach D, seem to largely be a result of changes in land-use in the upper reaches over the period of time studied, including logging and increased agricultural production. The aggrading sand bars and the presence of sand on the bed of the main thalweg infers that the channel does not have enough energy to transport all of the sediment entering the system in these reaches. A positive feedback loop is occurring in many locations as the accretion of bars deflects flow to the outer meander banks, thus leading to bank erosion and failures, delivering further sediment to the channel.

Figure 44 – Dominant bed material at each RGA site along the Buttahatchee River, and selected tributaries.

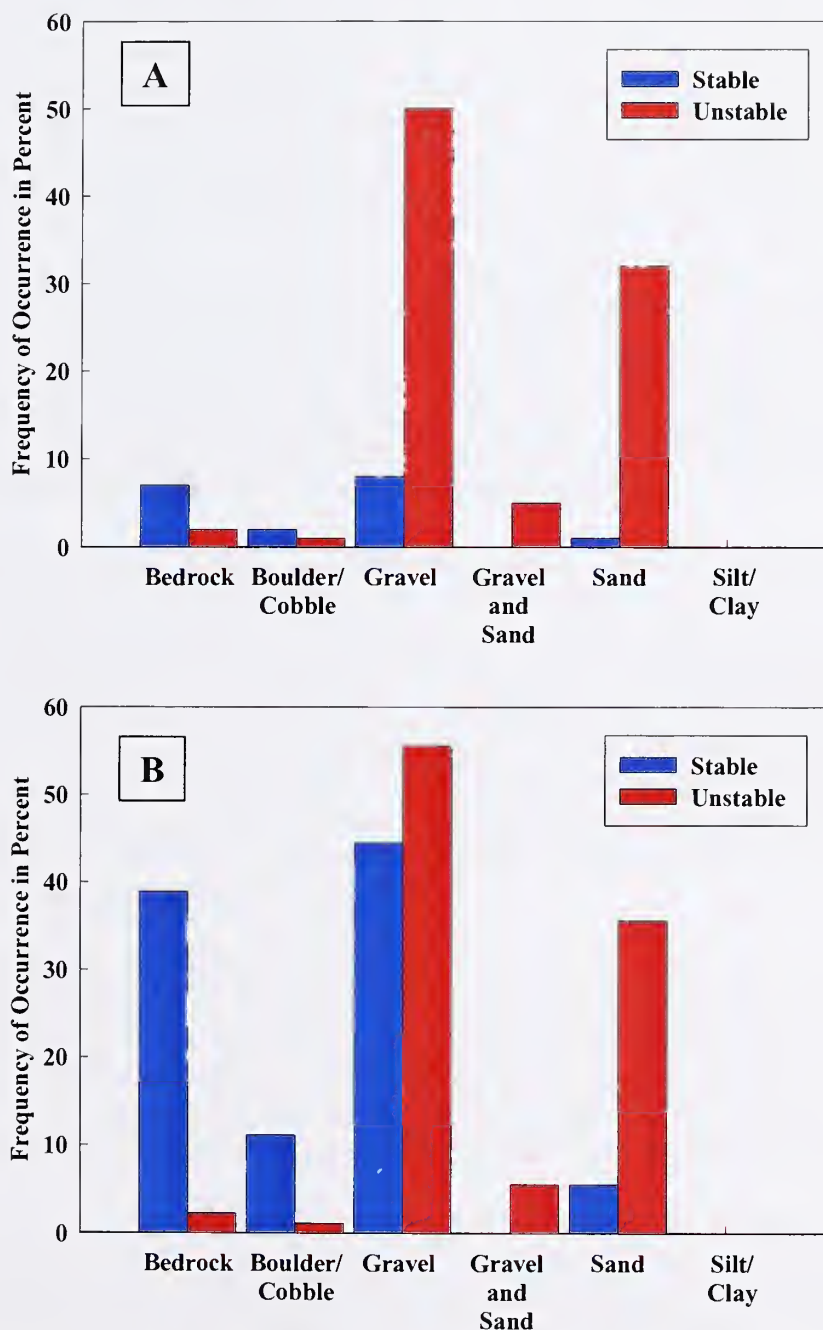
Bed material was compared for stable versus unstable sites. As there were very few stable sites compared to unstable sites, two graphs are presented in Figure 46: A shows the actual number of sites with each dominant bed material and B shows the percent occurrence of each bed material type for stable and unstable sites. All but one of the stable sites had bed material dominated by gravel, boulder/cobble or bedrock (Figure 46A). The unstable sites predominantly had bed material composed of gravel and/or sand.

**Figure 46 – Bed material at stable and unstable sites on the Buttahatchee River A) frequency of occurrence and B) Percent frequency occurrence.**

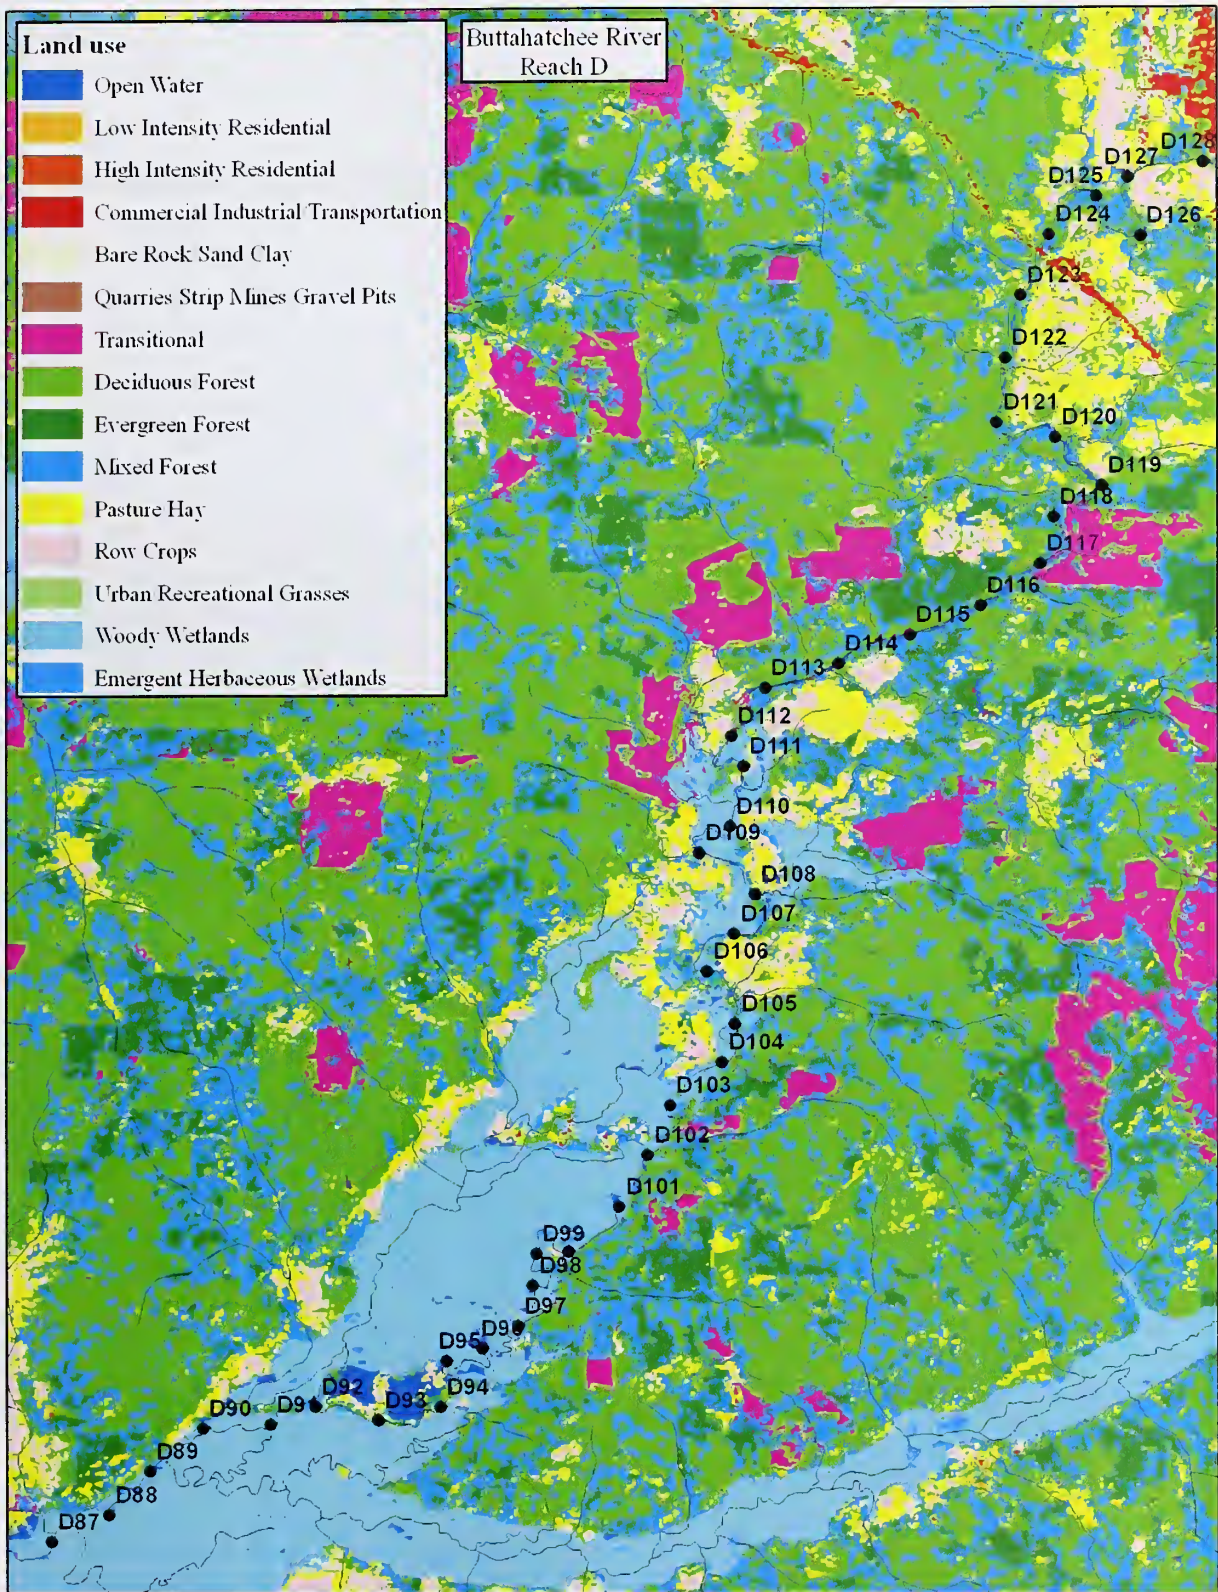
Figure 52 – 1999 land use reach D.

One point that stands out on Figure 52 (land use for reach D) is that there seems to be a sudden change in land use types at approximately rkm 112. Upstream of this point the land use cover category ‘woody wetland’ is no longer present, indicating that there may be a change in topography at this point that restricts the extent of the floodplain and the formation of woody wetlands. A look at the topography for this reach confirms this change: A narrow valley exists between rkm’s 114 and 119, but around rkm 114 the river

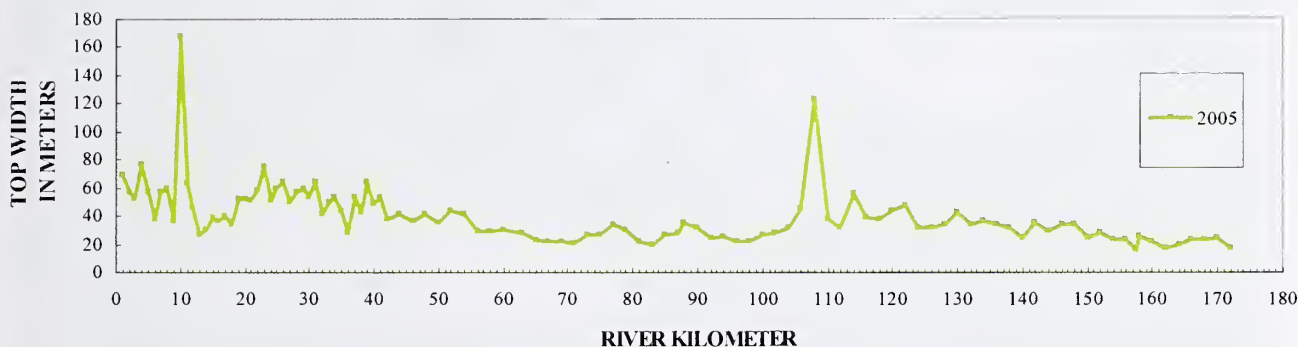
**Figure 55 – Bank top-width for rkm 0 to 172 (Reaches A to F) of the Buttahatchee River.**

A large change occurs in top-bank width at approximately rkm 106 (Figure 55). Downstream of this point the channel widths attenuate, generally showing a decreasing trend moving upstream from the mouth of the Buttahtachee River. In reach D, top widths seem to increase suddenly (Table 11) and then attenuate again upstream. This change in channel top widths is a pattern that can be seen in all of the air photos, dating back to 1958, but the pattern becomes more distinct after localized erosion occurring sometime during the 1958-1981 period. The explanation for these increases in top width in reach D can be explained when a number of factors are considered.

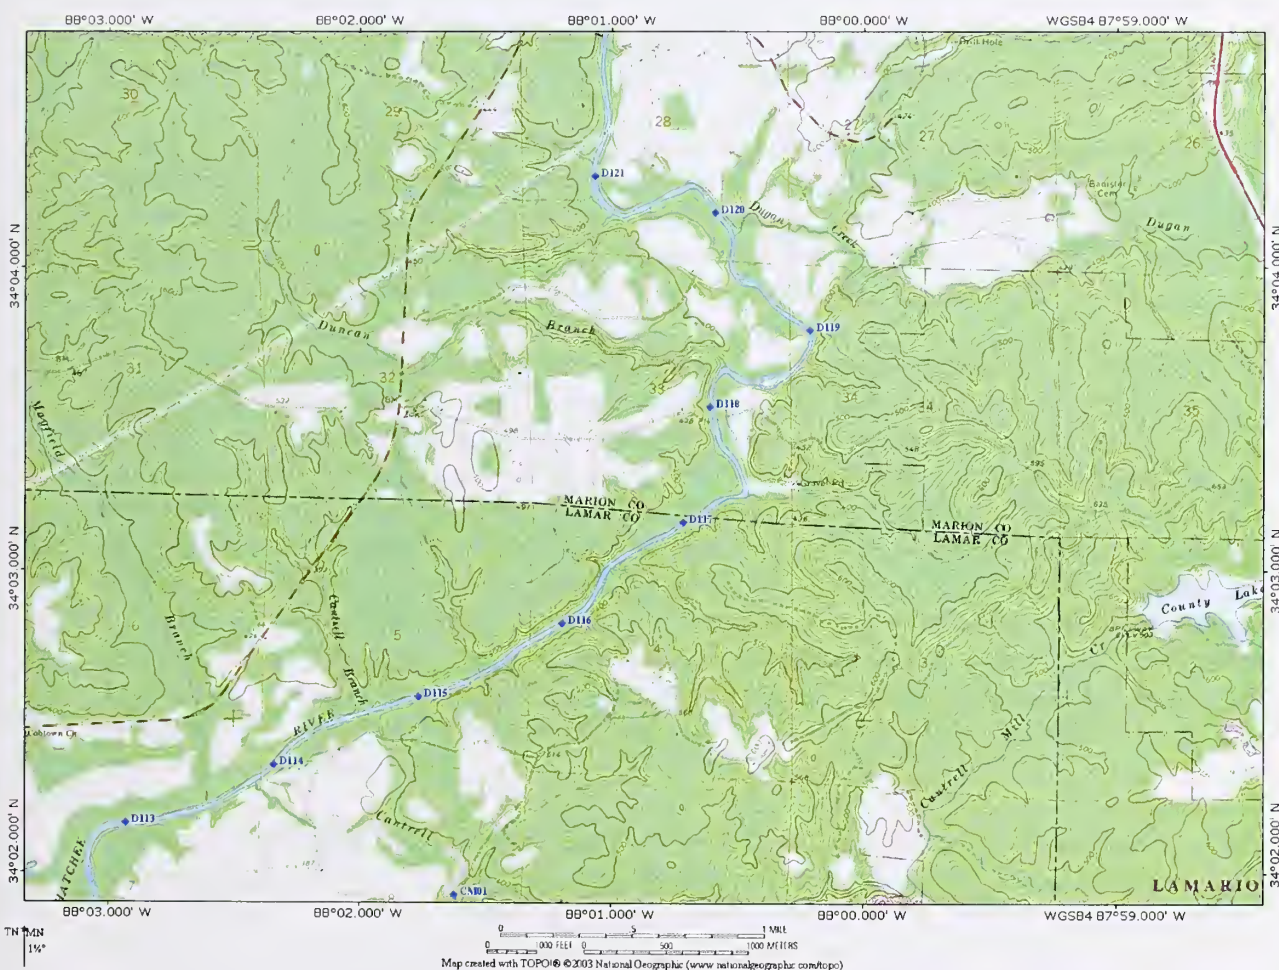
enters a region of open alluvial floodplain (Figure 56). During high flows, water is constricted from rkm's 112 to 117 by the steep topography adjacent to the channel, but at rkm 112, the narrow valley opens out again and the floodwaters can spill out onto the floodplain, depositing alluvial material. These alluvial deposits and flatter topography make ideal agricultural land, and in this reach current agricultural land use is indeed concentrated from rkm's 103 to 114 and then again from 119 and upstream. Analysis of the aerial photography also shows that there has been an increase in the amount of land cleared for agriculture and logging over the 35-year period of study in this reach. The timing of increased erosion in reach D points to changes in land use being a dominant control on widening rates in this reach. Downstream of approximately rkm 104, agricultural land use close to the channel is reduced considerably, and Figure 55 shows that downstream of this point, channel widths are narrower again, supporting the idea that land use in reach D has an important control on channel morphology.

**Figure 56 - Topographic representation of rkm's 112 – 128 in reach D, showing the transition of the narrow valley at rkm 115-119 to the open alluvial floodplain both up- and downstream.**

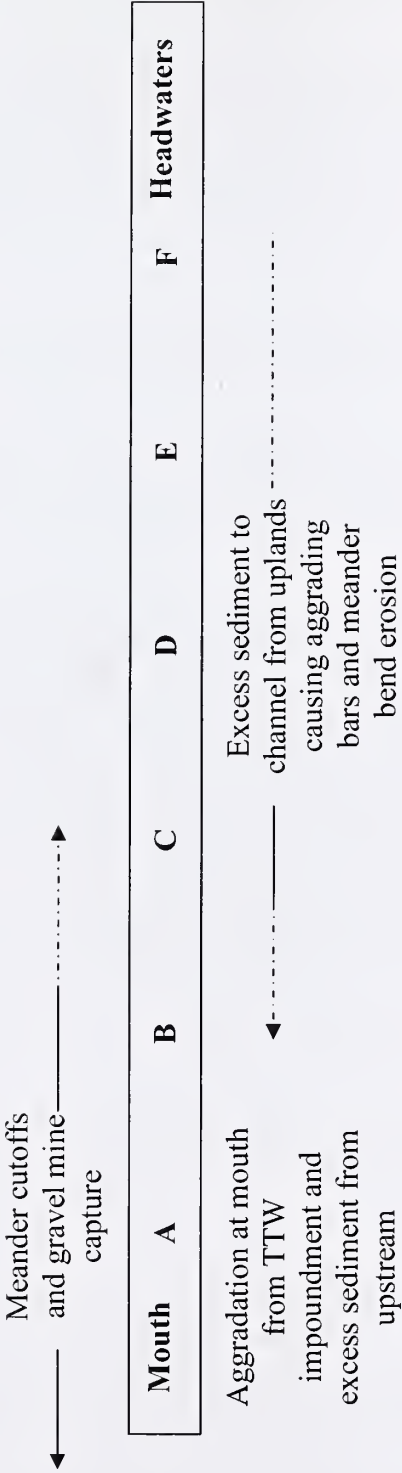
The instability seen in the Buttahatchee River therefore seems to be a result of disturbances that have occurred in two different reaches. Most of the channel modifications have affected reach A (TTW construction, meander cutoffs, gravel mine capture) and the effects of these disturbances can now be seen to have migrated upstream as far as reach C. In reach D significant instability also exists in certain parts of the reach, and this appears to be a result of an imbalance between sediment delivery and flow energy in the channel. Logging and increased agricultural land use in the proximity of the channel over the period of study, have led to considerable delivery of sediment to the channel in this reach. As a result, a positive feedback loop has developed, involving bar accretion and associated erosion of outer meander bends. The effect of disturbances in the Buttahatchee River are thus working their way both upstream and downstream from the sites of original disturbance, creating a complex pattern of response. The causes and direction of responses to these disturbances are summarized in Figure 61. As can be seen in Figure 61, the responses to disturbances in reaches A and D are moving in opposite directions and therefore have complex effects on the channel's response and search for a new quasi-equilibrium condition.

Figure 61 - Summary of disturbance locations and the direction and extent of the responses to these disturbances.

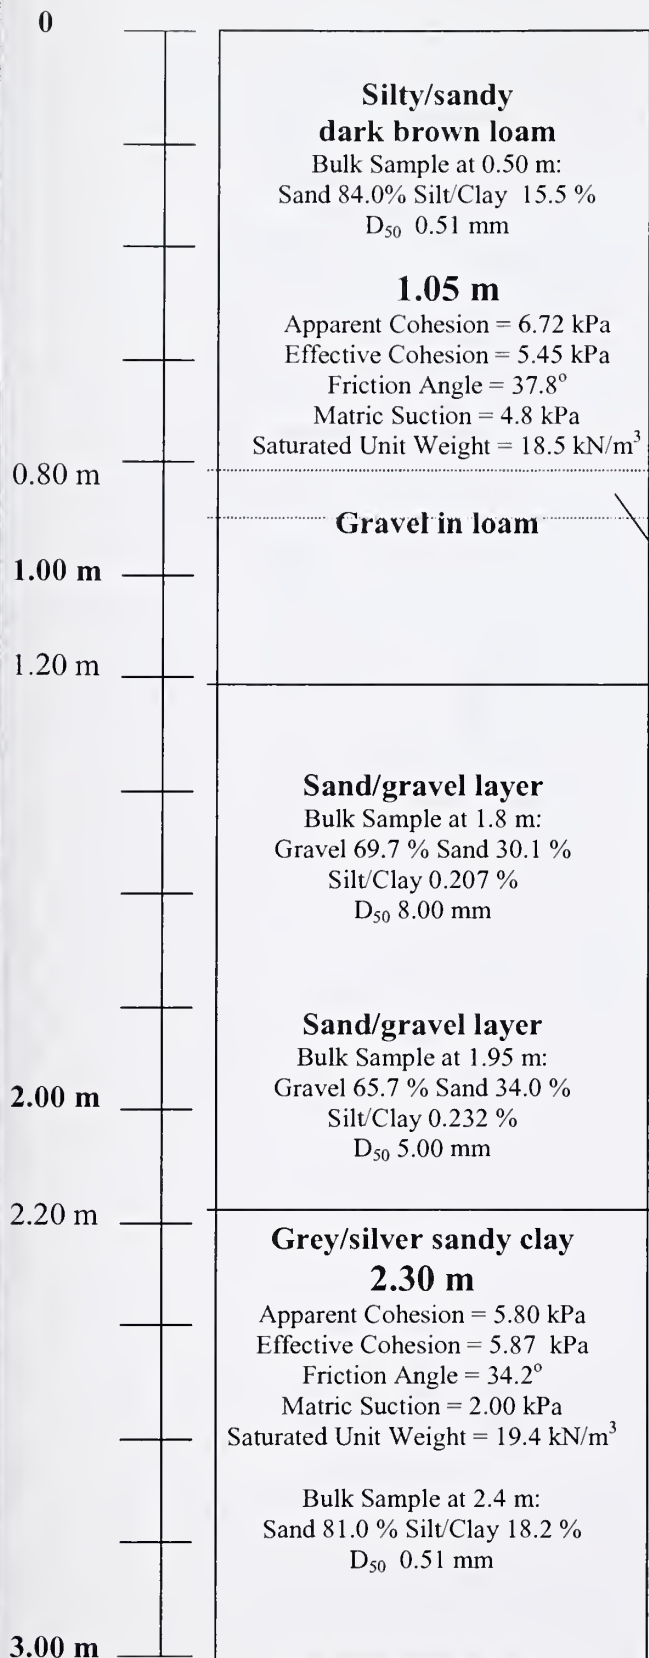
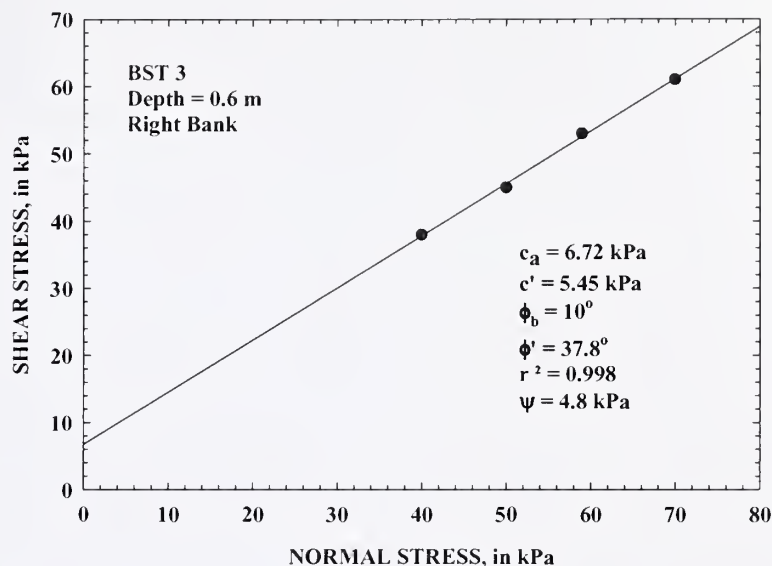
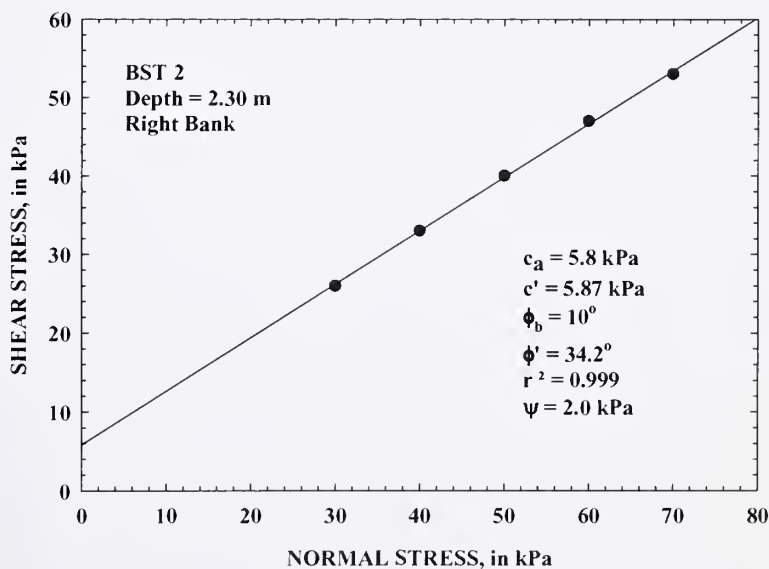
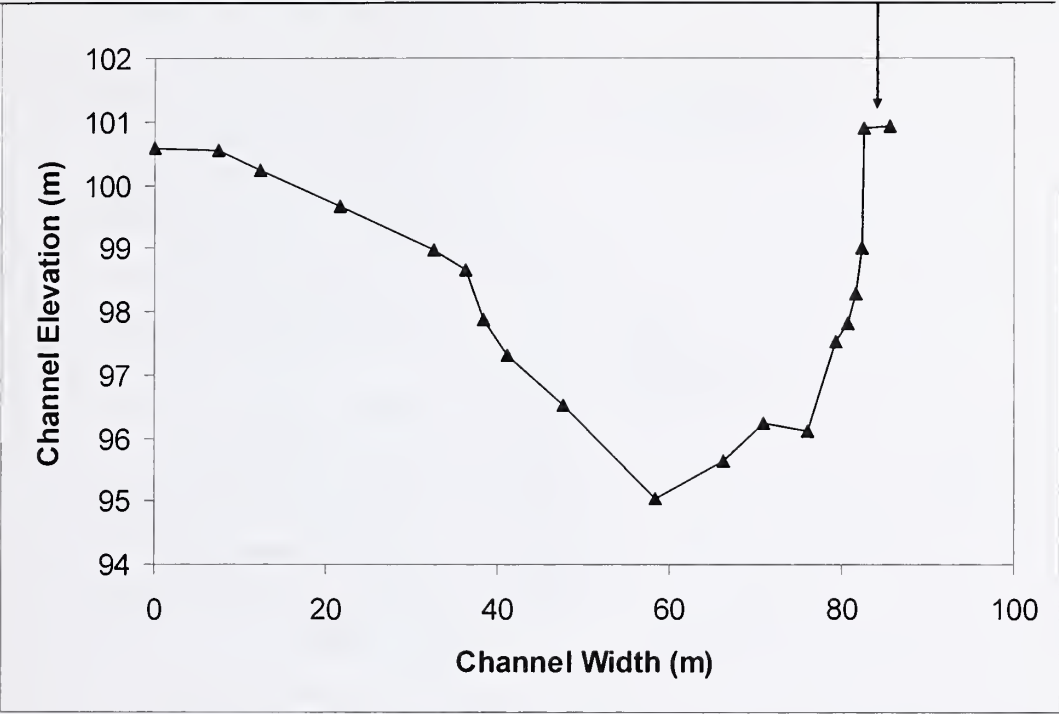
## A10 Left Bank

The banks tested at A10, C71 and D88 were generally found to be stable, until water table heights rose to 75 % of the bank height, at which point bank resisting forces are decreased sufficiently by the generation of pore-water pressures, for bank failures to occur even under high flow conditions. Only at 95 % bankfull flow depths does the confining pressure from flow overcome the decreased resistance from saturation and decreased resistance of the bank material from the higher water table.

Bulk Sample at 0.8 m:  
Gravel 70.0 % Sand 28.3 %  
Silt and Clay 1.71 %  
 $D_{50}$  4.2 mm

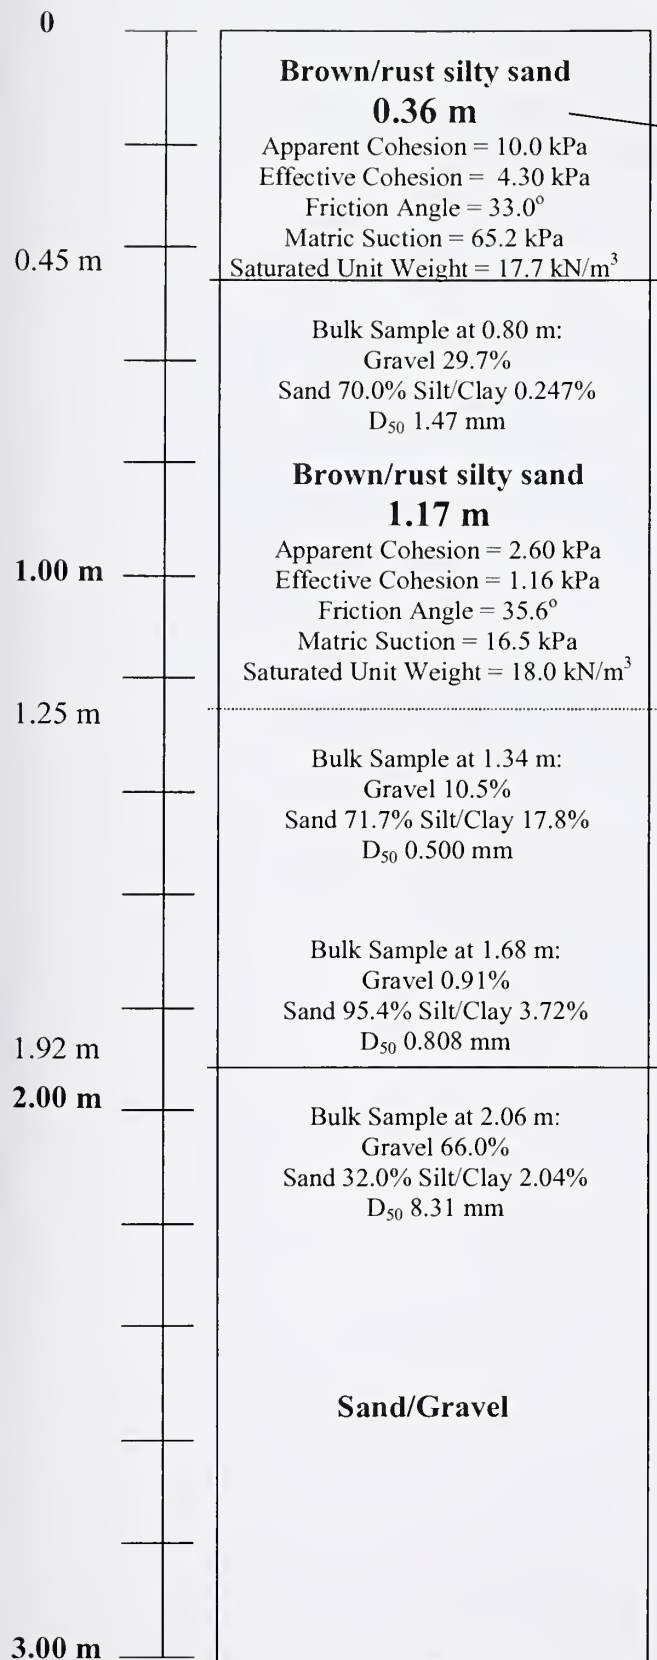
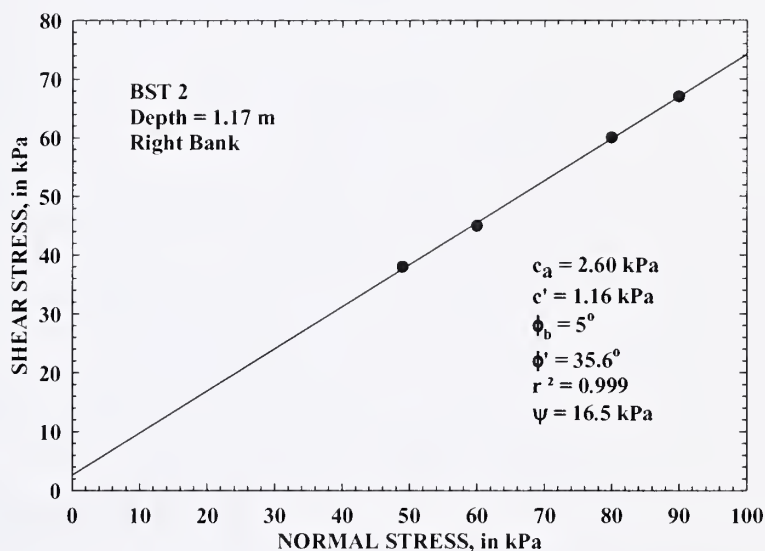
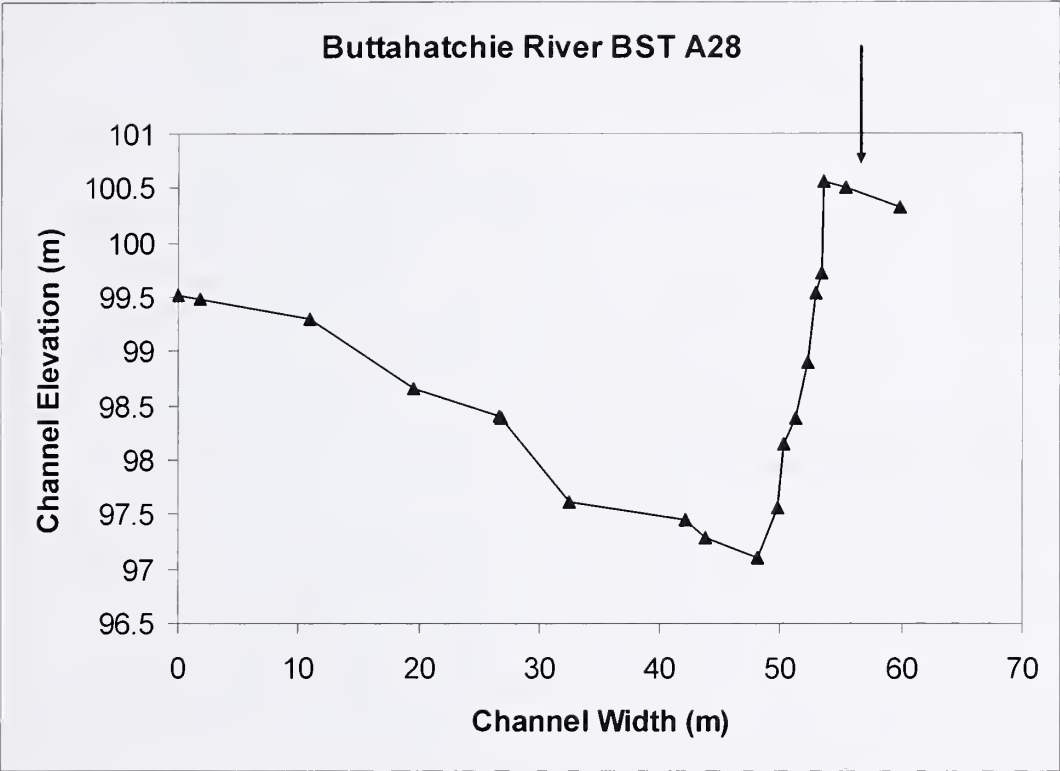
## A28 Right Bank

The bank stability results indicate that the banks tested at sites A28 and B42 were either conditionally stable or unstable under the widest range of flow and water table conditions. Indeed, for these two banks, the only times that banks were predicted to be stable were under high flow conditions at which time the confining pressure from the flow provides a stabilizing force to the bank. The upper part of the A28 bank profile was predominantly sand, containing some gravels and a small proportion of clay. High apparent cohesion in the uppermost layer (10.0 kPa, 0 - 0.36 m) decreased in the second layer as gravel and sand content increased. The bank layer at the base of the bank was dominated by gravel and sand, providing little cohesive support to the bank and a layer susceptible to undercutting by hydraulic forces.

Bulk Sample at 0.27 m:  
 Sand 92.6% Silt/Clay 7.41%  
 D<sub>50</sub> 0.810 mm

Increasing the relative stability of these banks is a matter of decreasing bank angles and thereby decreasing the driving forces, or conversely, increasing the resistance of the banks to mass failure. This can be accomplished by protecting the bank toes from hydraulic erosion and undercutting using rock or other materials that deflect flow or by increasing the geotechnical strength of the banks. The latter option can sometimes be accomplished by the planting of riparian vegetation, which provides reinforcement through the establishment of a root-soil matrix.
